# CASAR<sup>®</sup>

# WIRE ROPE FORENSICS

by Dipl.- Ing. Roland Verreet and Dr. Isabel Ridge

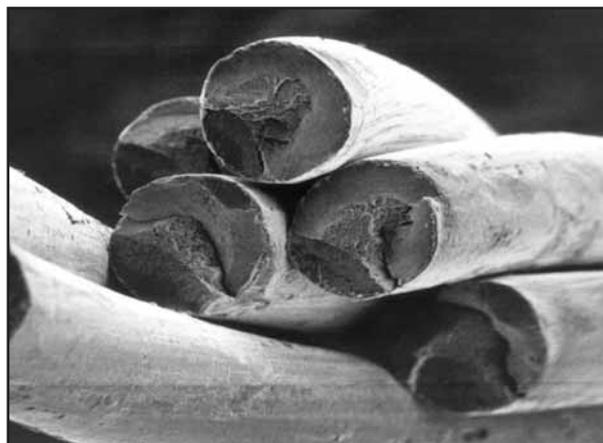
Fig. 12: Fatigue cracks starting at the points of contact of individual wires. The cracks became visible after destroying the strand in a pull test.

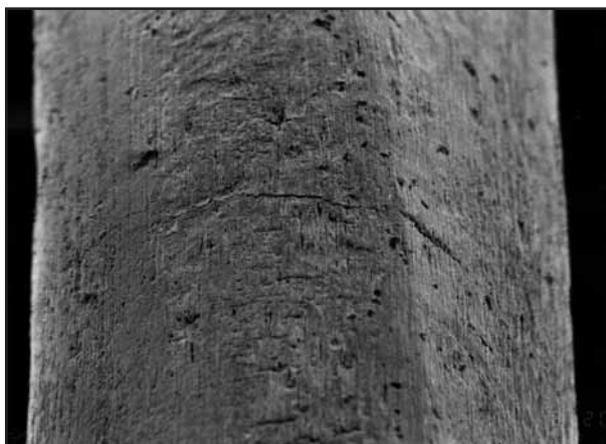
Fig. 13: Surface corrosion often initiates the formation of fatigue cracks.

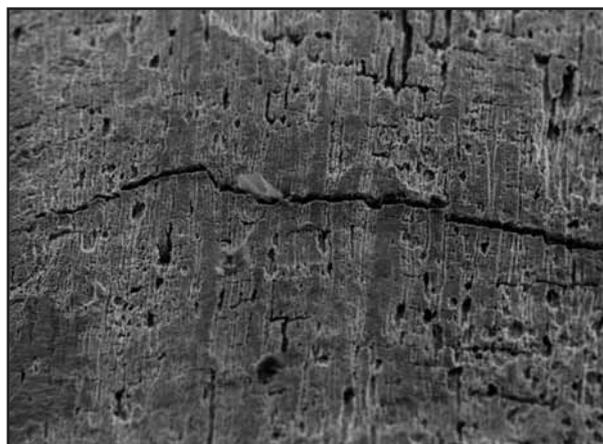
Fig. 14: Pitting and corrosion associated with a fatigue crack (detail of Fig. 13).

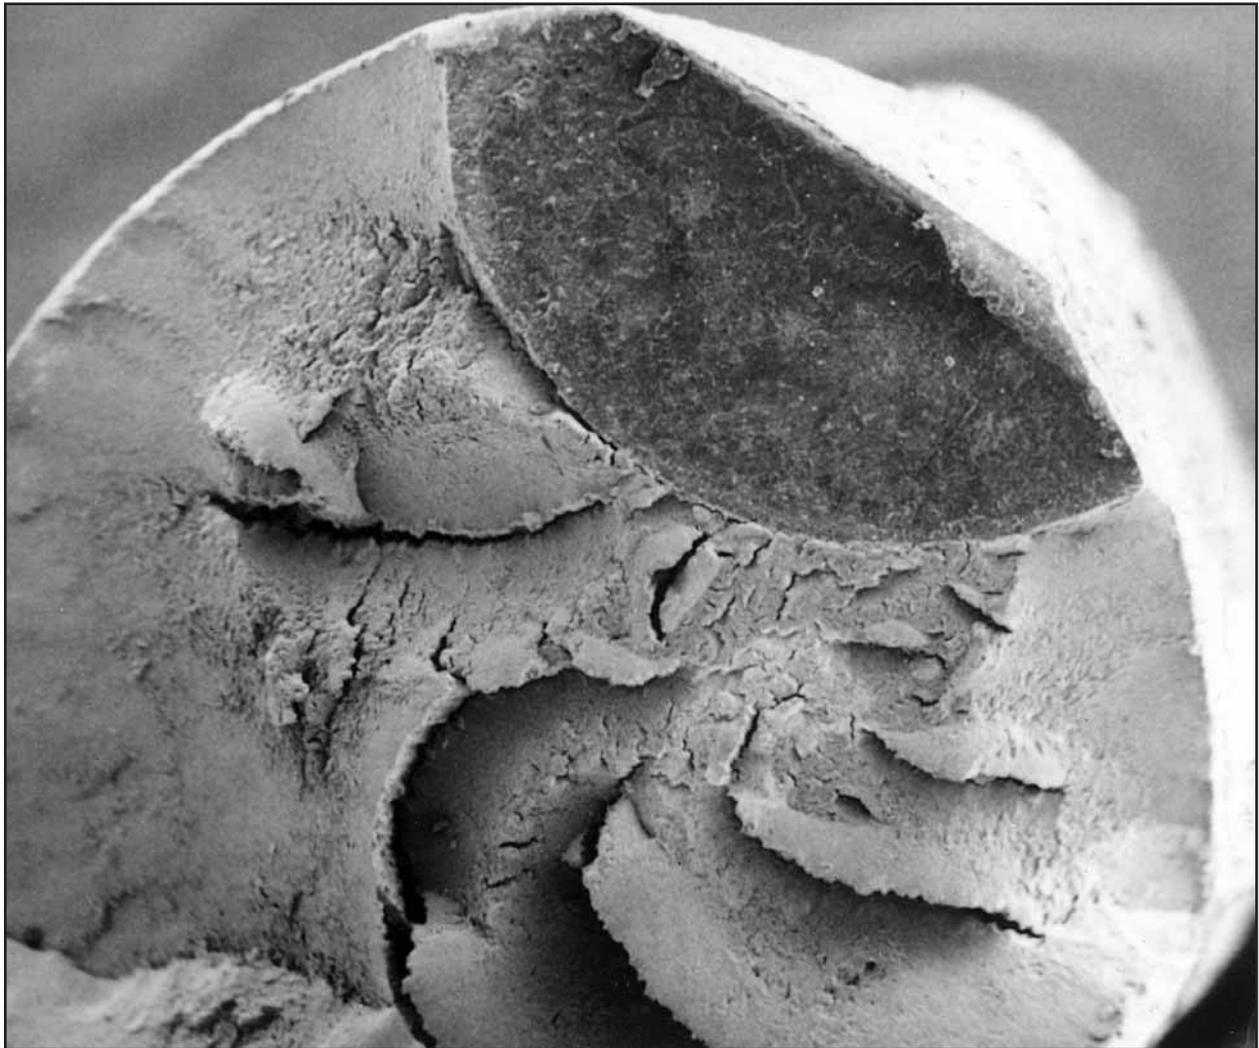
Fig. 15: A fatigue crack starting at the point of contact with a sheave. Obviously the crack propagated concentric to its point of initiation. The crack only became visible after destroying the strand in a pull test.

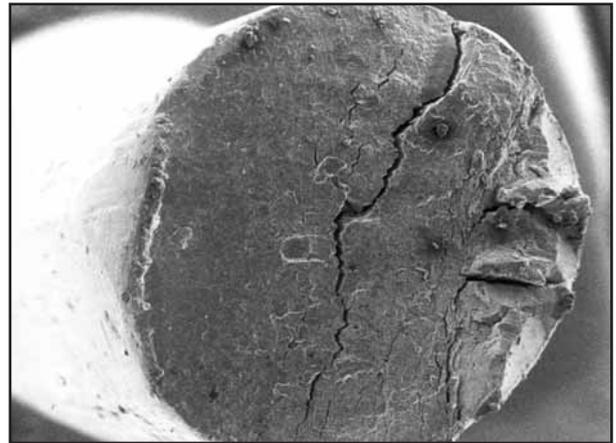
Fig. 19: Another fatigue crack.

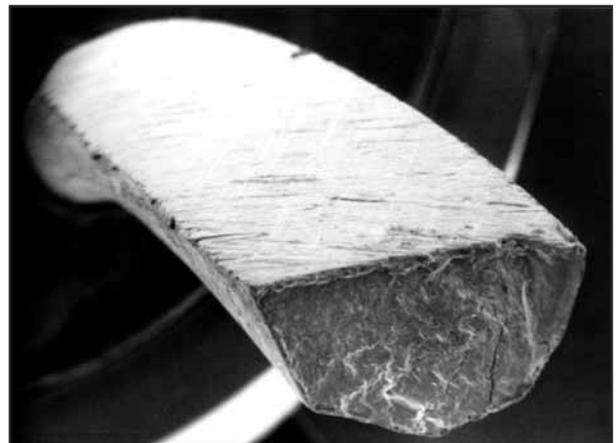
Fig. 21: Severely worn wire with a fatigue break.

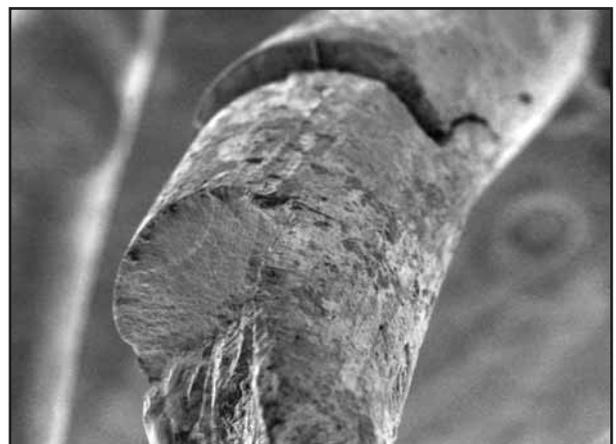
Fig. 23: Two adjacent fatigue cracks. This kind of failure can often be seen if wires are subjected to local bending and compression.

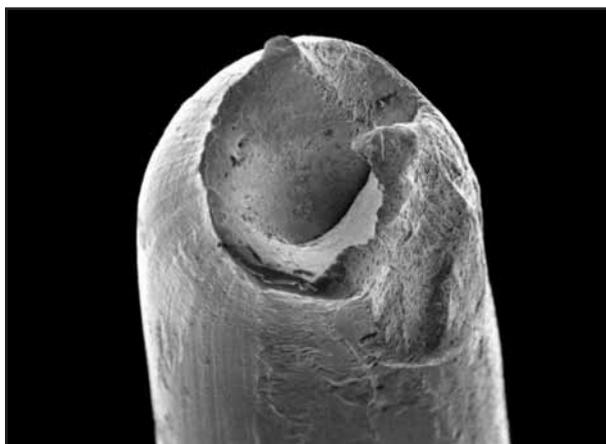
Fig. 39: This locally damaged wire finally failed in tensile overload.

Figs. 35 and 36 show typical examples of a tensile overload break. Fig. 39 shows an example of a wire which was first locally damaged by external influences. Once weakened, it failed in tensile overload.

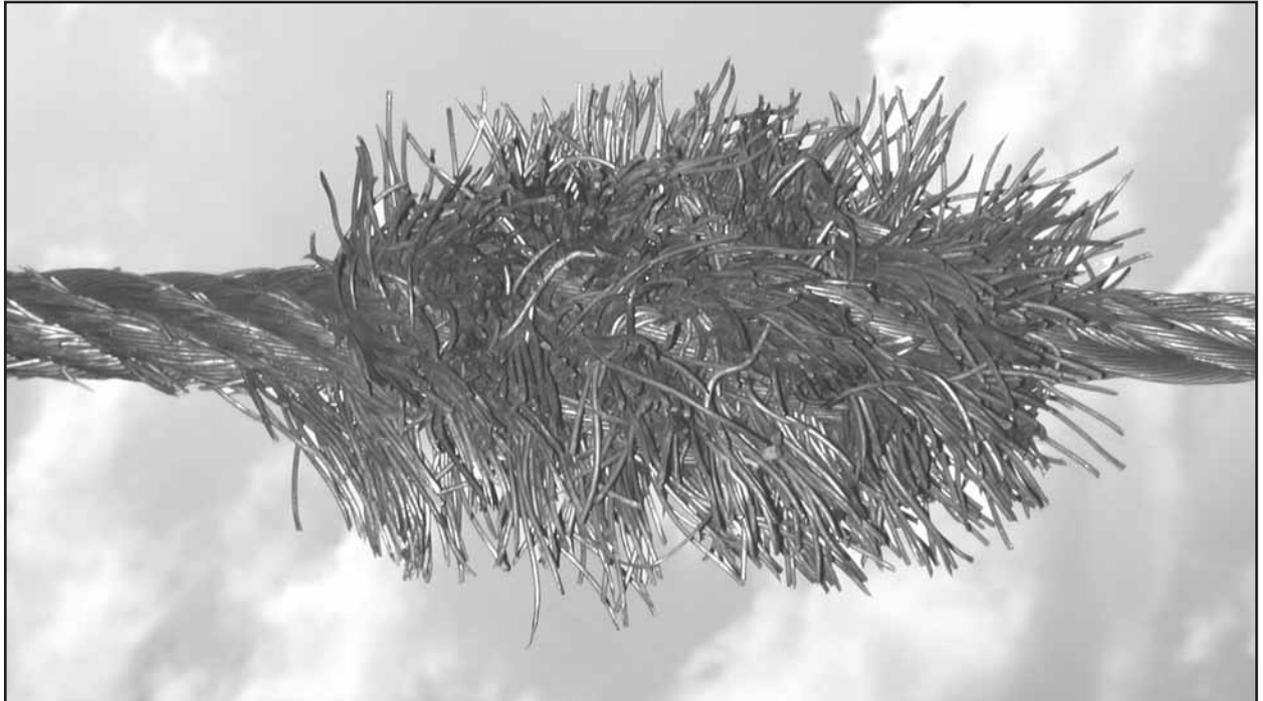
Fig. 61: Closing rope of a grab crane. All the outer wires had broken due to severe abrasion. The flared exit funnel of the grab has pushed all loose wire ends along the rope length to one location, creating this impressive hedgehog.

Fig. 61 shows a closing rope of a grab crane. All outer wires had broken due to severe abrasion. The flared exit funnel of the grab has pushed all the loose wire ends along the rope length to one location, creating this impressive hedgehog.

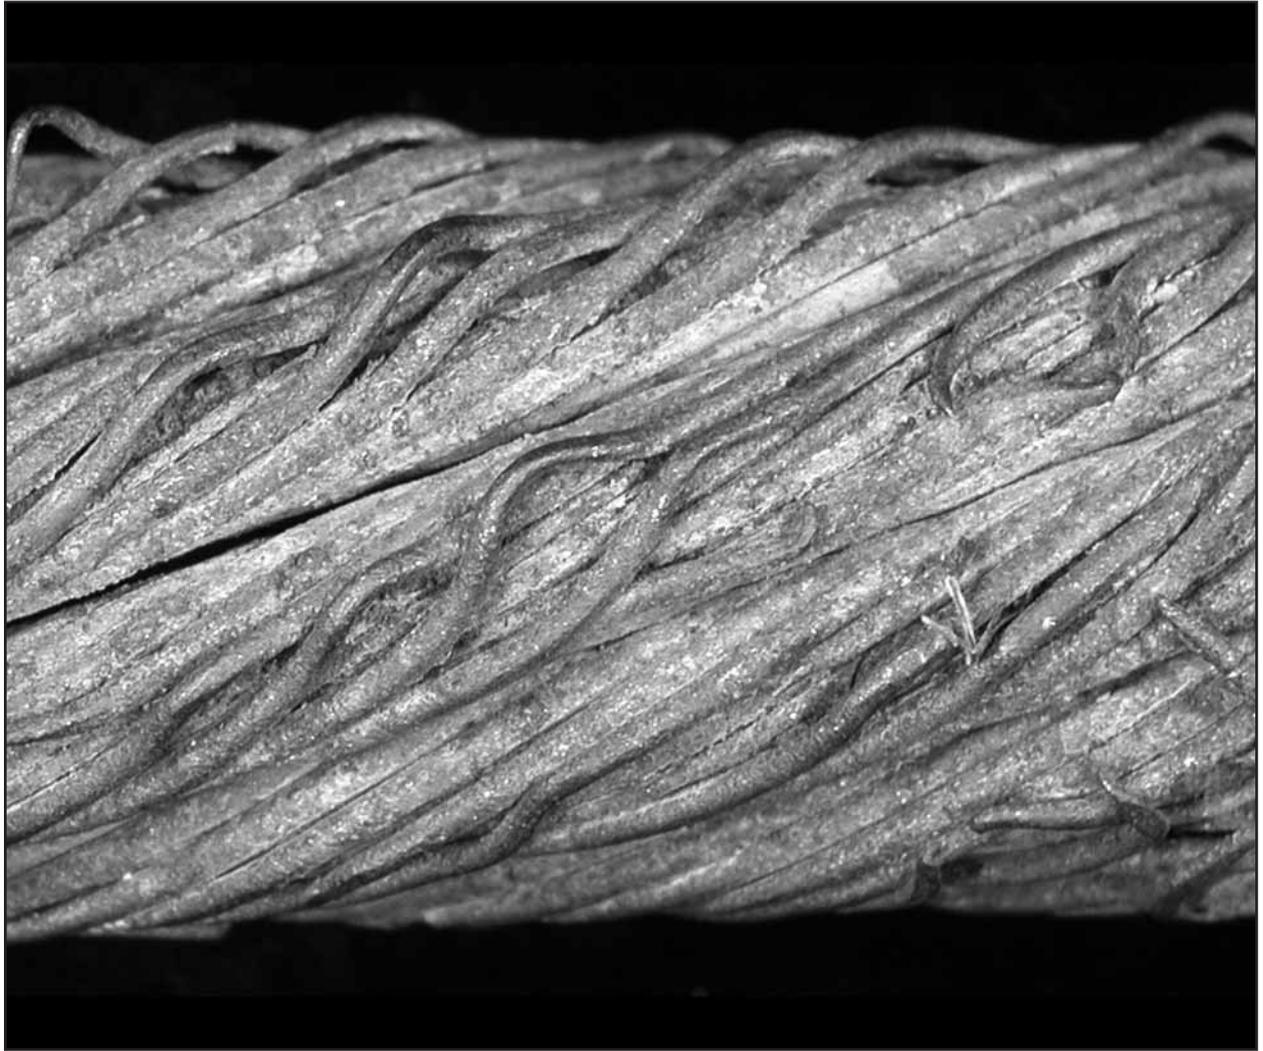
Fig. 80: This hoist rope from a ladle crane has been exposed to elevated temperatures for too long. As a result of this the outer wires have annealed, softened and then lengthened in service.

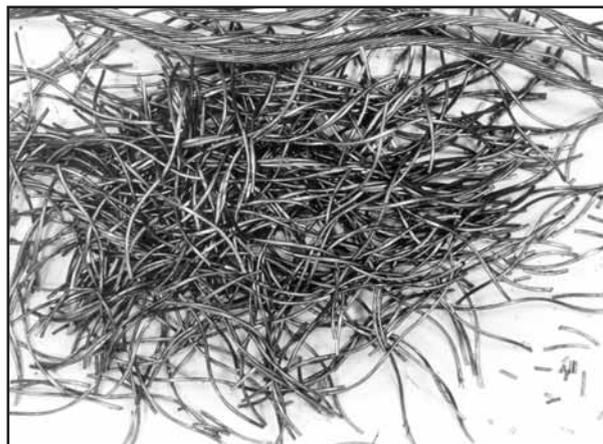
Fig. 85: Opening up this discarded steel wire rope proved that the steel core was no longer in very good condition.

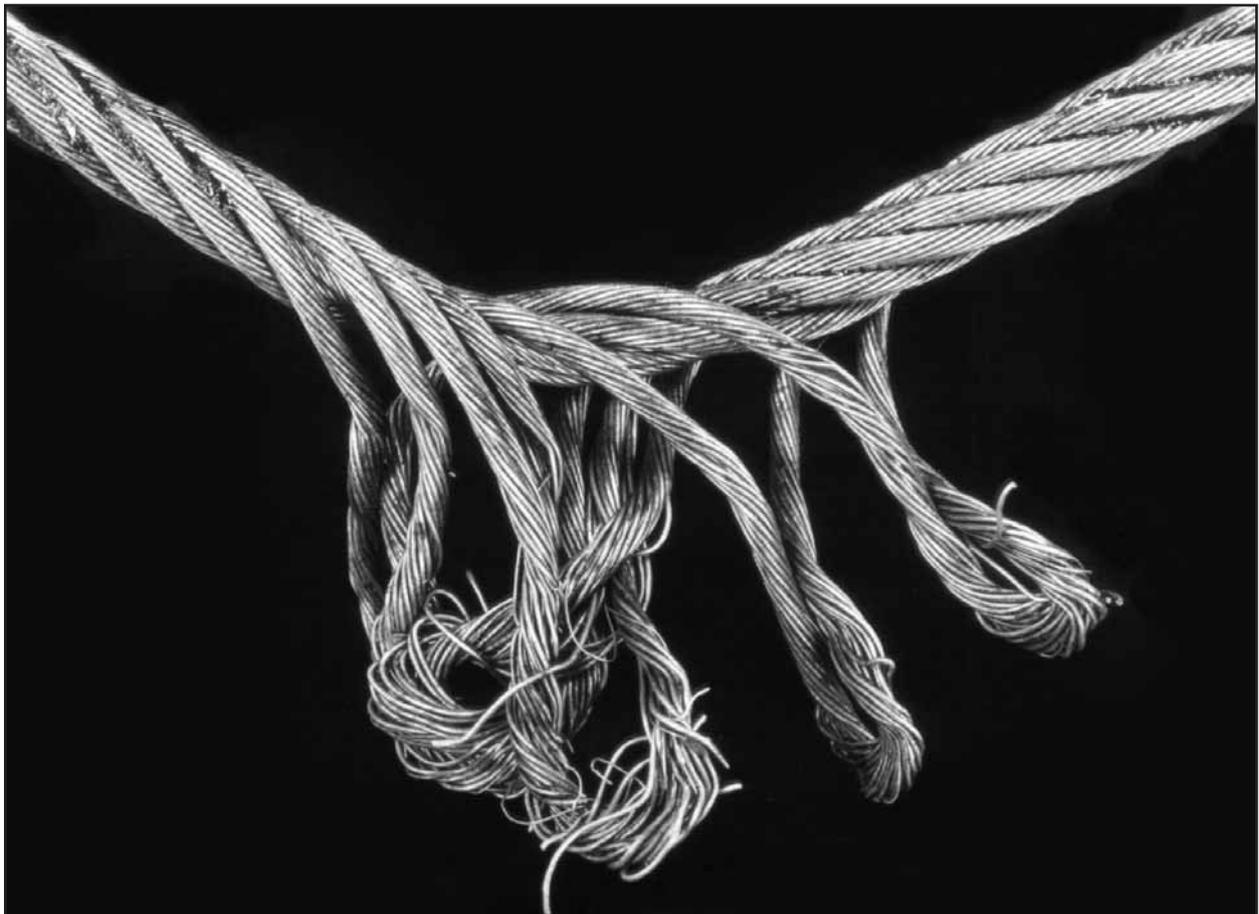
Fig. 107: This steel wire rope has been unlaid. In this state its outer strands are too long for the rope length. A sheave has accumulated the “superfluous” strand lengths to a point at the end of its travel.

A birdcage is a short section of rope in which the outer strands are much longer than the rope and therefore “stand up”. Birdcages are normally formed when a wire rope is opened up by twisting or by being twisted around its own axis. In an opened up (unlaid) condition, the outer strands are too long for the rope length, and the “superfluous” strand length is brought to one point by a sheave (Fig. 107). This is why birdcages are often found at the end of the sheave travel.

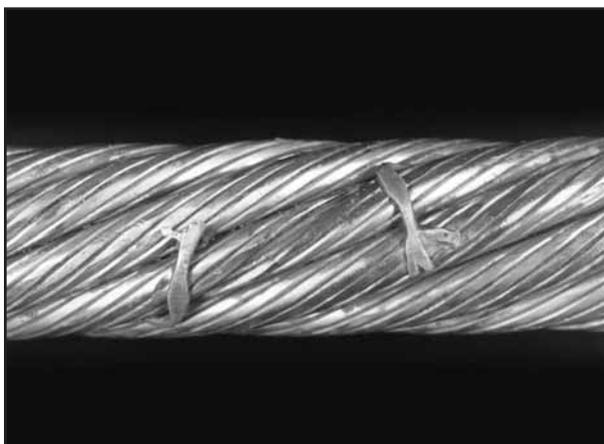
Fig. 116: These two broken wire ends got caught between the wire rope and the sheave causing nicking damage.

If a long end of a broken outer wire catches and is bent across its neighbouring strands, it will easily get caught between the wire rope and the sheave causing nicking damage. This is especially relevant to Langs lay ropes where the exposed wire ends are always long (Figs. 116 and 117).

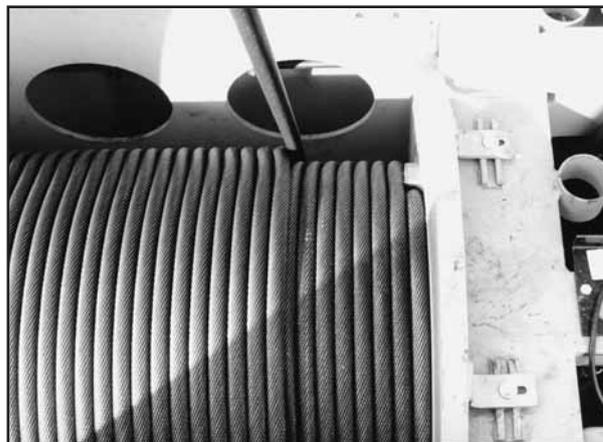
Fig. 126: This rope is spooling onto a multi layer drum with special grooving. The rope is about to cross over one wrap.

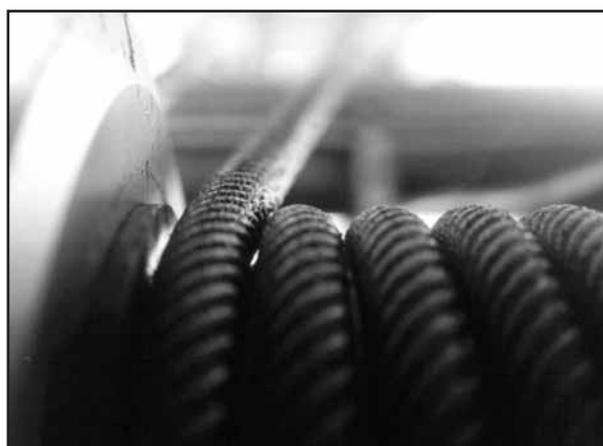
Fig. 128: The fleet angle forces the rope fall entering the drum to rub against its "neighbour", causing severe abrasion and rope twist.

be pulled against a neighbouring wrap (Fig. 128) or against the flange of the drum groove (Fig. 130). In both cases, the rope surface will be damaged.

Fig. 129: Abrasion and plastic wear (see page 4) caused by rubbing against a neighbouring rope wrap (see Fig. 128).

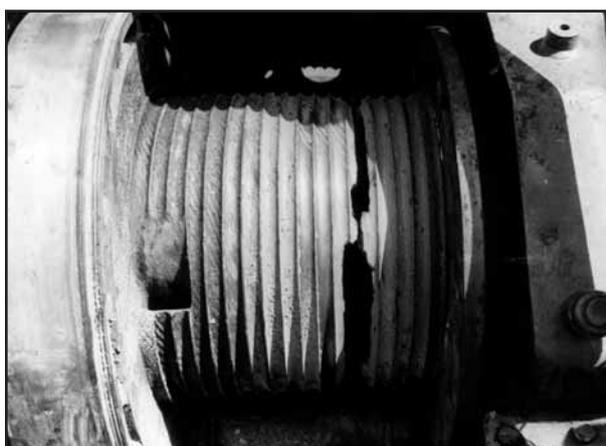
Fig. 134: If the load is always picked up at the same location, always the same sections on the drum and on the rope will be worn.

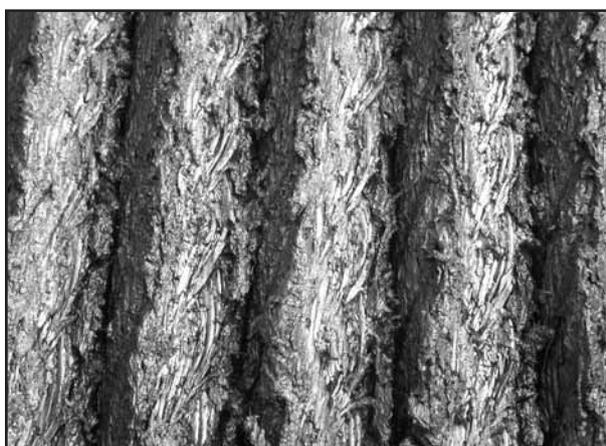
Fig. 136: Rope damage on a multi layer drum. It took one of the authors a considerable time to convince the user that...

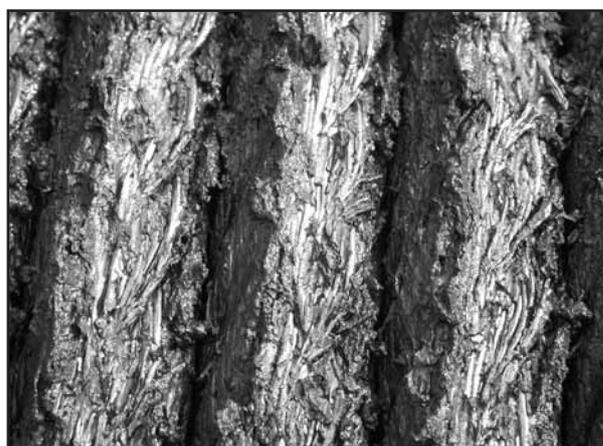
Fig. 137: this rope was ready for discard (see Fig. 136). Further examination showed that every outer wire was broken every 3 cm.

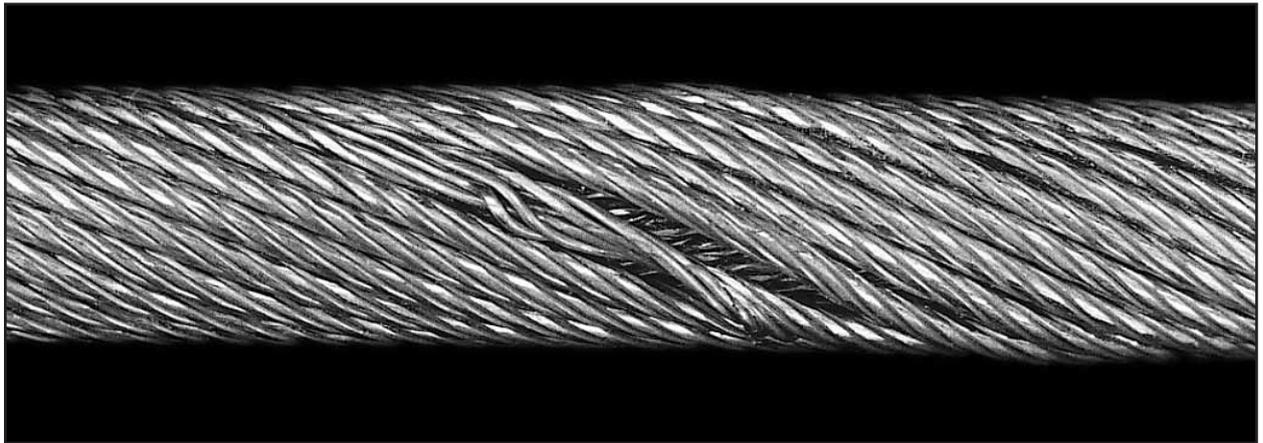
Fig. 143: During stranding, one strand obviously had slipped on the capstan, locally creating a long lay length. This stranding defect was not detected before the faulty strand was closed into the rope.

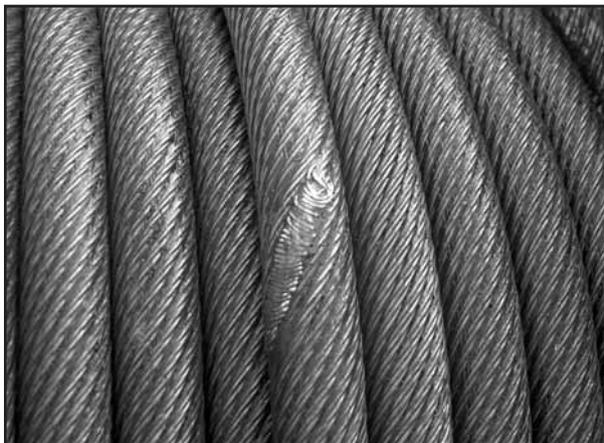
Fig. 144: A strand serving was not removed during rope closing and ended up as an unpleasant decoration of the finished rope.
